OFFSHORE HISTORIC ARTIFACT SURVEY
GAAN POINT, AGAT SMALL BOAT HARBOR
TERRITORY OF GUAM

Samuel T. Price and John Craib

U.S. Army Corps of Engineers
Pacific Ocean Division
Contract No. DACW84-77-C-0019
Mod. No. P00011

February 1978

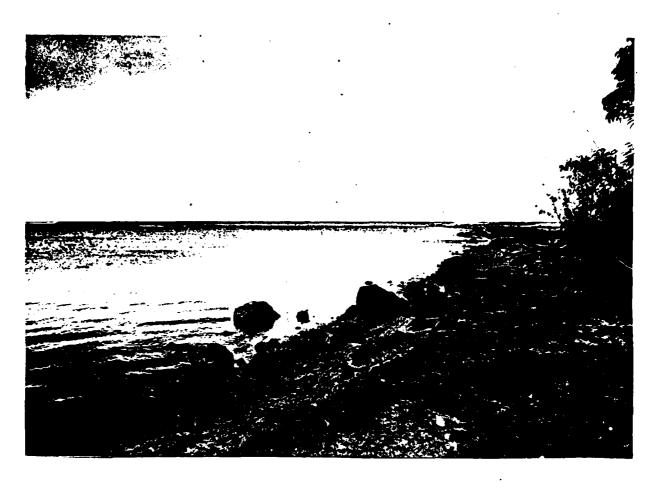
Fig. 5. REEF AREA OFF GAAN POINT, AGAT, GUAM, FACING SOUTHWEST.

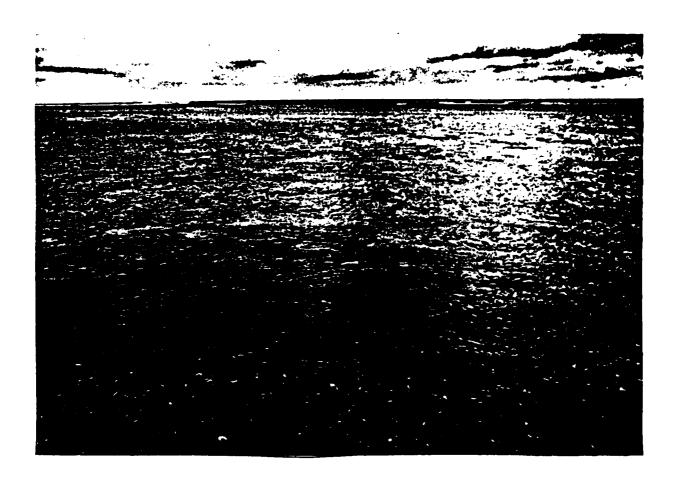
The remains of a collapsed Japanese pillbox (Feature 1) were found under 2 ft of water c. 12 meters from the line of strand vegetation and 40 meters south of the base of Gaan Point (Fig. 2), c. 5 meters west of a single, large, apparently stationary boulder. This feature is located outside the proposed federal construction project area. The walls of the pillbox have collapsed seaward and appear somewhat intact (Figs. 6 & 7). The majority of the foundation is still secured on the reef, though two small pieces lay immediately to the north. No artifacts were found that could be directly associated with the feature.

Fig. 6. VIEW OF FEATURE 1, JAPANESE PILLBOX, UNDERWATER NEAR GAAN POINT, AGAT, GUAM.

In the channel area, a retrieval of materials (e.g., the anchor) should be undertaken, as well as further investigation of the cables, which may have served as defensive blockades for the Japanese. Since Feature 1, the pillbox, is part of Agat Invasion Beach, a National Register site, it is recommended that the Advisory Council on Historic Preservation be consulted to determine whether or not it should be preserved. It appears that enough of the original feature remains so that restoration would be possible if desirable.

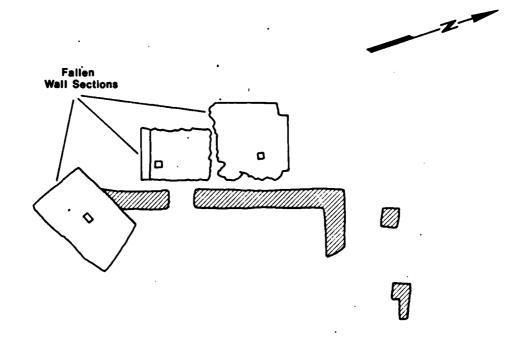
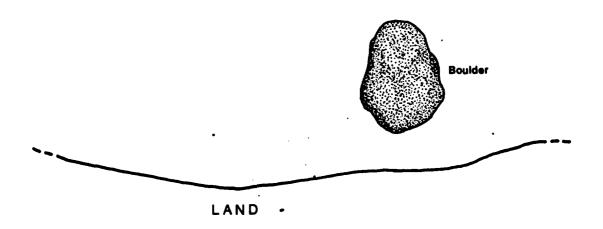
Fig. 7. PLAN OF PILLBOX FEATURE 1, GAAN POINT, TERRITORY OF GUAM.

AGAT BASIN UNDERWATER SURVEY **FOUNDATION FEATURE NO. 1** JAN. 25, 1978
